**NOSC TR 516**

# COMPOSITE-UNIT ACCELERATED LIFE TESTING (CUALT) OF SONAR TRANSDUCERS

September 1979

Final Report for Period March 1978 - September 1979.

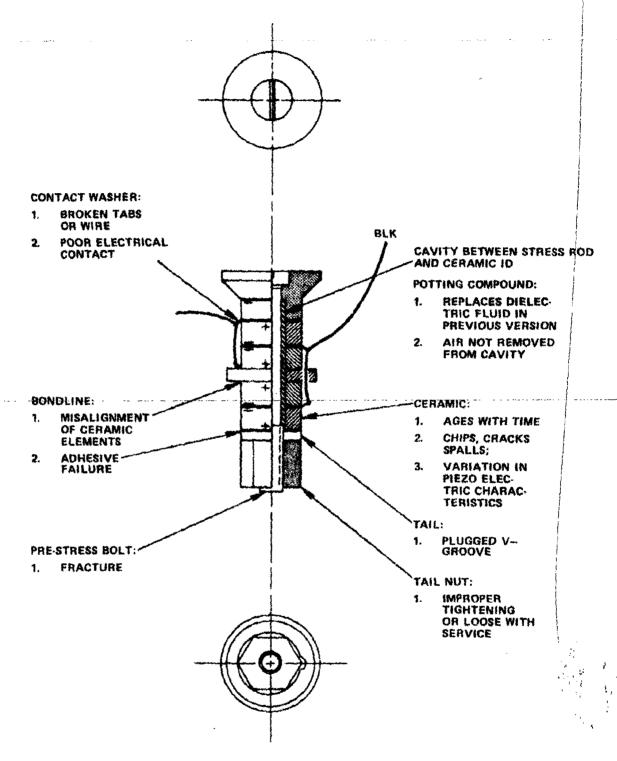
Figure 4-1. Resonator-Array Failure Sites

It was conjectured that the air was never successfully removed from the cavity in the resonators between the stress rod and the inside of the ceramic rings (see figure 4-1) during the fill-fluid fill operation. This was believed due to the extremely small size of the ports (a tiny groove in the tail mass) intended for fill-fluid entrance into the cavity. It was further conjectured

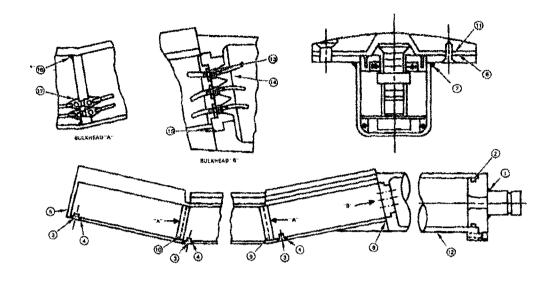
Figure 4-3. Failure Sites in TR-316 Transducer Envelope

1.	Weld	Receptacle to transducer cover.
2.	O-Ring Seal	Transducer cover to housing.
3.	O-Ring Seal	Oil fill hole screw.
4.	Weld	Oil fill hole boss.
5.	Weld	Housing end piece.
6.	Flat Gasket Seal	Rubber window.
7.	Weld	Housing to housing flange.
8.	Weld	Cylindrical housing casting to housing.
9.	Weld	Housing to housing.
10.	Weld	Housing to housing.
11.	Bond	Clamping to rubber windows.
12.	Casting	Cylindrical housing.
13.	0-Ring	Hermetically sealed header to bulkhead.
14.	Connector	Hermetically sealed contact.
15.	Weld	Bulkhead to housing.
16.	Bonded Rubber Seal	Bulkhead to housing.
17.	Potted Seal	Conductor to bulkhead.

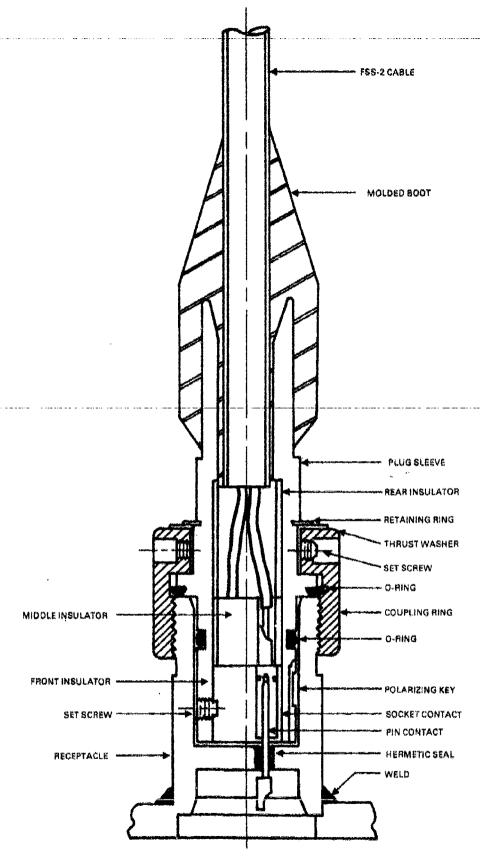
Figure 4-5. BUSHIPS DWG 815-1197170 Hermetically Sealed Connector

- 6. Add a note to require the manufacturer's identification and serial number on each cable assembly.
- 7. Should the plugs be molded with neoprene, revise and update the BUSHIPS Drawing 815-1197170 wiring and molding procedures. A substitution must be made for the KNR neoprene polymer, which is no longer available from DuPont.
- 8. In shipping, package the cable/plug assembly separate from the transducer assembly. The two plug assemblies and transducer receptacle should be fitted with protective caps.
- 9. Delete the use of the coupling-ring set screws on the Drawing 815-1197170 plug assembly.

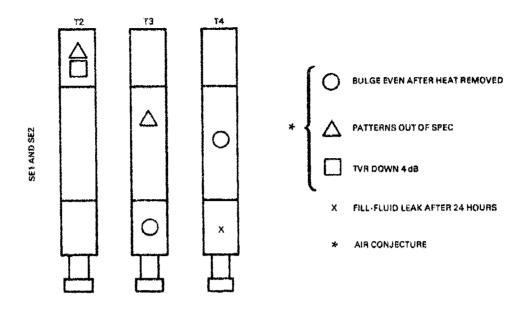
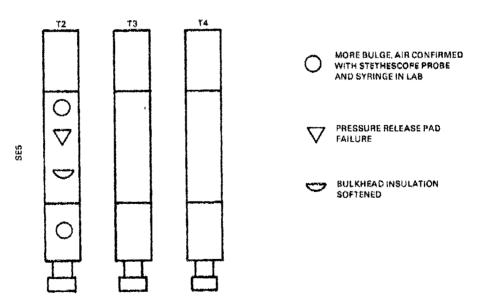
During stress exposure 5 (thermal shock) it was found that more bulges remained in the rubber windows of T2N and T2U (marked with O). Immediately after SE5, air was confirmed as described later with stethoscope probes and an air removal syringe. It was also found upon disassembly that the pressure

SE3 and SE4 - No additional problems observed

Units modified and repaired at Straza-meet CIPS Figure 6-1a. CAULT Problem Summary for SE 1 through SE5

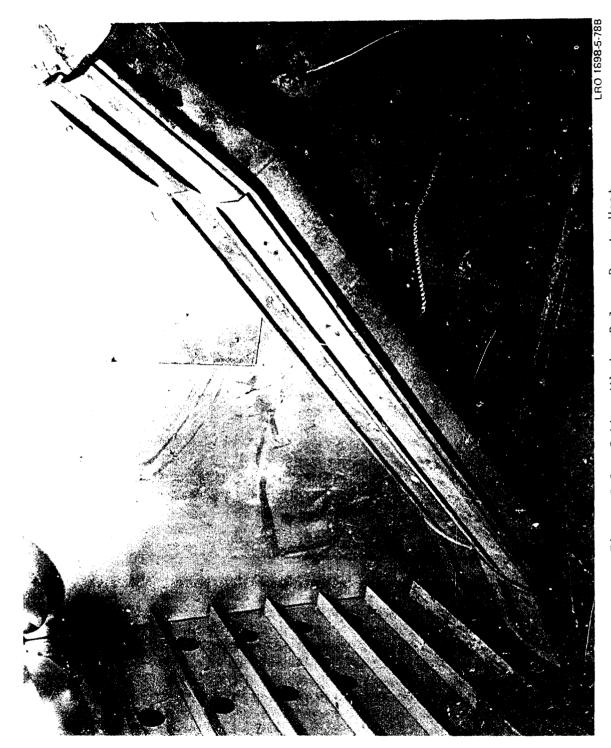
Figure 6-2. Rubber Window Bulges Due to Heat

that heating during SEI and SE2 forced some of this air out into the fill fluid, but that the small vent ports did not allow the fill fluid to reenter the ceramic stack cavity in the resonators. It would then follow that this air trapped in the fill fluid accounted for the permanent bulge after the heat was removed.

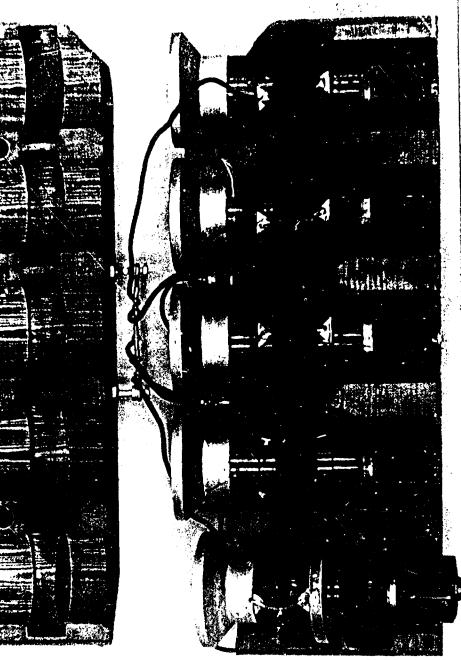
This section summarizes the status of the current-runaway problem as of the end of the first-year-equivalent CUALT of the TR-316. Most of the short sections, (PD up and PD down sections, also known as wide beam sections) failed the high-drive test. Recall that the problem manifested itself during high-level-drive testing as a current runaway versus time, culminating in failure of certain resonators (probably due to excessive heating). None of the long sections (known as the narrow beam sections) had high-drive problems. The explanation for this is as follows: the transformer/electrical impedance characteristics of the long sections are such that the 23 resonators of the narrow beam sections draw the same power as the 5 elements in the wide beam sections. There were no high-drive failures in the narrow beam section simply because the resonators in these sections operate at a much lower drive level (i.e. power level) than the wide beam (short) sections.

Figure 6-12. Discoloration of Mounting Block at Godal Mount Location

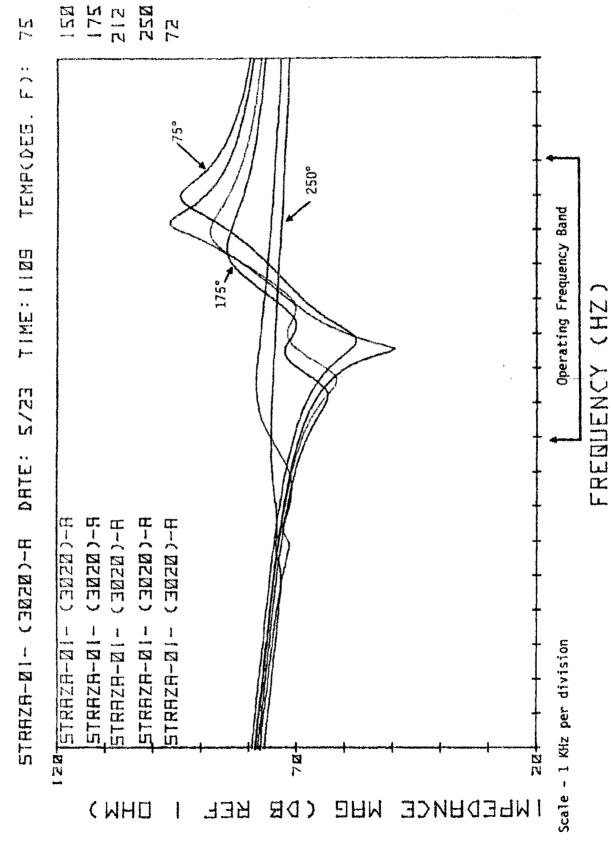
Magnitude of In-Air Impedance Vs. Temperature for a "Bad Resonator" Figure 6-14a.

In figures 6-14a (In-Air Impedance Magnitude) and figure 6-14b (In-Air impedance Phase Angle), typical in-air impedance results versus temperature are presented for "bad resonators" from production transducer resonators used in the prototype TR-316s and similar to those from sections which failed the high-drive CUALT. This original Straza resonator, STRAZA-Ol-(3020)-A, was a PD wide beam section from S/N 1 Unit without Sylgard 184. Notice that results are presented for temperature measured in degrees Fahrenheit and appropriately color-coded for temperatures of 75°F (23.9°C), 150°F (65.6°C), 175°F (79.4°C), 212°F (100°C), 250°F (121.1°C), and 72°F (22.2°C). Even the highest of these temperatures, 250°F (121.1°C), is still well below the temperature for which the piezoelectric material normally encounters temperature problems. theless, even at 150°F (65.6°C), one observes in figures 6-14a and 6-14b a serious deterioration for the bad resonators. As the temperature is increased to what should still be a safe value of 250°F (121.1°C), one observes from the curves that all indications of the normal transducer resonance have disappeared, and indications of extreme losses have become evident. just as in the composite TR316's, after the temperature is allowed to return to normal, even the "bad resonators" recover. Of course in the case of the composite TR316's, when the current was allowed to increase without limit, resonators were finally destroyed.

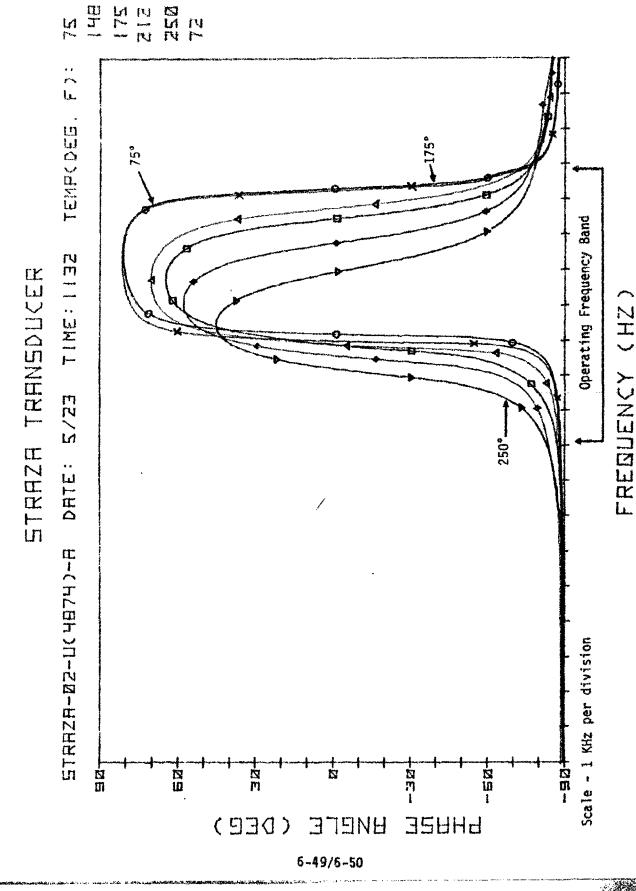
Figure 6-15b. Phase Angle of In-Air Impedance Vs. Temperature for "Allegedly Good Resonator"

In figures 6-15a and 6-15b, typical in-air impedance results are presented for "allegedly good resonators" from T2 which passed the ocean portion of the high-drive tests. This original Straza resonator, STRAZA-02-U(4874)-A, was a PD up beam section from S/N 2 Unit with Sylgard 184.

Although the deterioration versus temperature is not nearly as devastating as in the case of the "bad resonators," nonetheless, serious deterioration of the resonator's performance is indicated. Specifically, in figure 6-15a, for the magnitude of the in-air impedance, one notices a drastic shift downward in the resonance frequency versus temperature, as well as a drastic deterioration in the dB spread between  $F_n$  and  $F_m$  — once again indicating unacceptable increases in losses versus resonator temperature. The bandwidth, as indicated by the difference in frequency between  $F_n$  and  $F_m$ , is also deteriorating with increasing temperature. The corresponding results for the in-air impedance phase angle shown in figure 6-15b present an alternate indication of the same deterioration in resonator performance versus increasing temperature. Notice, as in the case of the "bad resonators," the "good resonators" recover when the temperature is allowed to return to low values, namely, approximately 75°F.

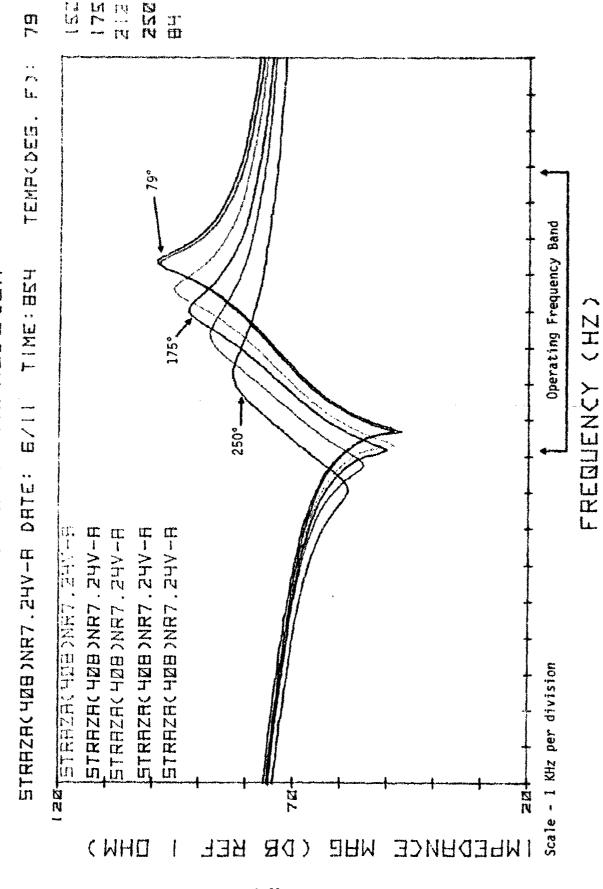
Figure 6-16a. Magnitude of In-Air Impedance Vs. Temperature with a Reduced Diameter Stress Rod

In figures 6-16a and 6-16b, the in-air impedance versus temperature results are presented for a resonator using a <u>reduced-diameter stress rod</u>. Straza resonator STRAZA (408)NR7.24V-A was constructed with Epon 8 adhesive (stressed with 2.8 N-m (25 in-1b) torque before adhesive cure) and a thinned-down stress rod (0D range from 0.47 to 0.30 cm or 0.186" to 0.120"). This resonator was considered to assure that the correct prestress was being applied to the piezoelectric stack via the stress rod. In order to maintain consistency prior to testing configurations 3, 6, 7 and 8 (as designated on page 6-33), a stress was applied by NOSC which developed 7.2 volts on a 0.97 microfarad capacitor. This voltage corresponds to approximately 30 kPa (4500 psi) prestress in the ceramic.

Based on this knowledge, it was speculated that in some transducers with the lower stress values, when accompanied by the extra-large diameter of the stress rod, one might encounter a condition where the stress rod released most or all of the prestress versus increasing temperature. It was further speculated that this could lead to a chain reaction that might account for the increase in current, and ultimately, the current-runaway condition. However, examination of figures 6-16a and 6-16b shows that the resonator incorporating a reduced-diameter stress rod and the proper stress still exhibited drastic detrimental changes versus increasing temperature. In particular, this resonator incorporating the reduced-diameter stress rod with the known recommended normal stress (nominally used in the Straza production) was no better than the "allegedly good resonators," whose results are indicated in figures 6-15a and 6-15b.

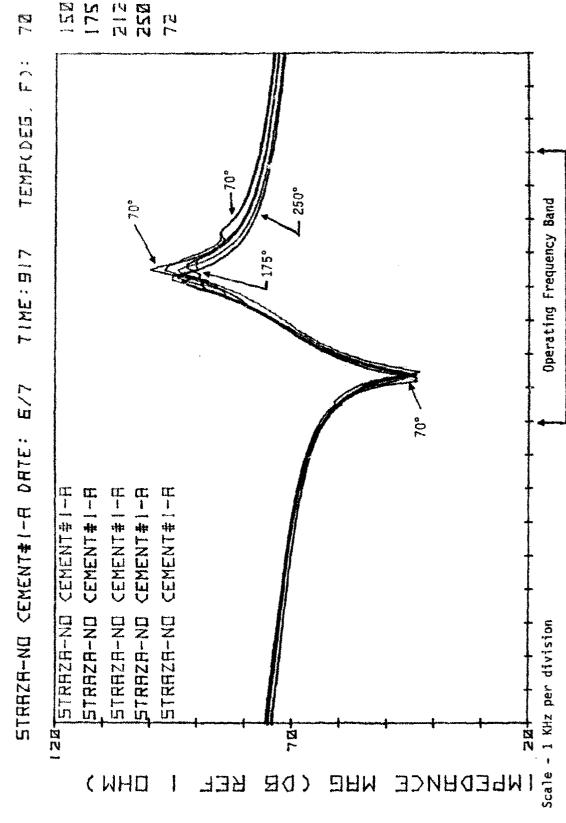
Figure 6-17a. Magnitude of In-Air Impedance Vs. Temperature with No Cement and High Prestress FREGUENCY (HZ

In figures 6-17a and 6-17b, the in-air impedance versus temperature results are presented for a resonator, STRAZA-NO CEMENT #1-A, with <u>no cement joints and a high prestress</u> in the production-line stress rod (the larger-diameter stress rod) equivalent to 11.3 N-m (100 in-1b) instead of 5.7 N-m (50 in-1b). Notice that there are practically no changes in resonant frequency or dB spread with increasing temperature for this non-cement joint radiator as compared to the previous resonators considered.

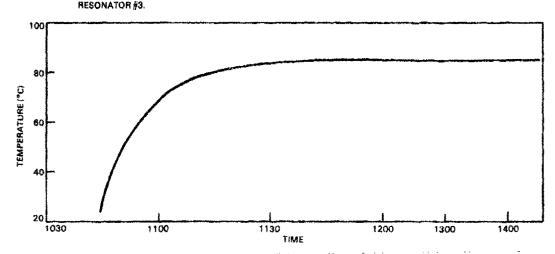
Figure 6-24. Transducer Stabilization Curve for Micarta Block, Δf, Epon 8, and New Assembly Technique Tested at 22°C

For the combination of Epon 8, new assembly technique, micarta block, and frequency sweep, the temperatures stabilized at 85°C (185°F) and 92°C (197.6°F) for initial water temperatures of 22°C and 32.2°C, respectively (figures 6-24 and 6-25).

TR-316 TRANSDUCER TEMPERATURE VS TIME WITH SWEEP FREQUENCY OF 120-130 V(rms) DRIVE IN 22°C (71.6°F) WATER AT 10.6 METERS DEPTH.

NEW RESONATORS (#1.2.3.4 & 5) WITH EPON 8 ADHESIVE, MOUNTED IN MICARTA RETAINER BLOCK, IN S/N 2 UNIT, PO DOWN BEAM. THERMISTOR BONDED TO NODAL RING OF CONTINUOUS 2 SEC. SWEEP UP AND 2 SEC. SWEEP DOWN, ALTERNATELY IN THE OPERATING FREQ. BAND.

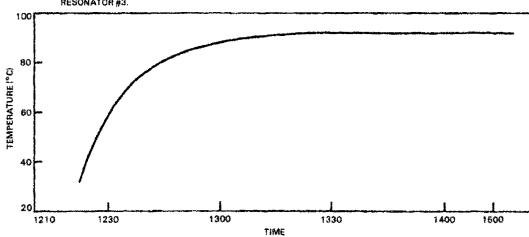
Figure 6-25. Transducer Stabilization Curve for Micarta Block,  $\Delta f$ , Epon 8, and New Assembly Technique Tested at 32.2°C

TR-316 TRANSDUCER TEMPERATURE VS TIME WITH SWEEP FREQUENCY OF 120-130 V(rms) DRIVE IN PRESSURE VESSEL WITH 32.2°C  $\pm$  1° (90°F  $\pm$  2°) WATER AND EQUIVALENT WATER DEPTH OF 12 METERS.

NEW RESONATORS (#1.2,3.4 & 5) WITH EPON 8 ADHESIVE, MOUNTED IN MICARTA RETAINER BLOCK, IN S/N 2 UNIT, PD DOWN BEAM. THERMISTOR BONDED TO NODAL RING OF RESONATOR #3. CONTINUOUS 2 SEC. SWEEP UP AND 2 SEC. SWEEP DOWN, ALTERNATELY IN THE OPERATING FREQ. BAND.

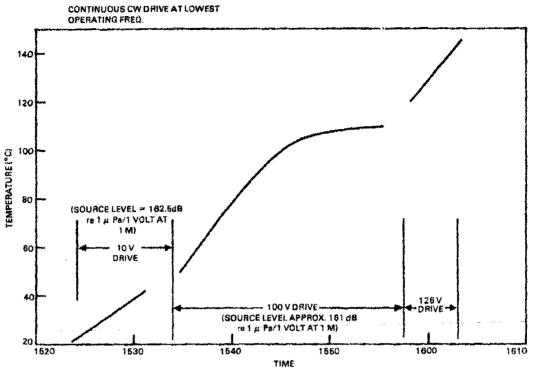
Figure 6-26. Transducer Stabilization Curve for Micarta Block,  $f_0$ , Epon 8, and Old Assembly Technique Tested at 22°C

For the combination of Epon 8 using the <u>old assembly technique</u> and a <u>micarta block</u> and <u>single-frequency drive</u>, the temperature reached 137.8°C (280°F) (figure 6-26) and was still rising with no apparent inclination to stabilize when the experiment was terminated. The temperature-rise experiment on the complete transducer in conjunction with the in-air impedance measurements explains why a runaway condition exists on the old transducers. The improperly formed cement joints were the cause of the problem. No other combinations using the old Epon 8 cement joints were considered because utilization of this construction had been definitely ruled out for the future.

### TR-316 TRANSDUCER TEMPERATURE VS TIME AS A FUNCTION OF DRIVE LEVELS AT 10.6 METERS WAYER DEPTH

- 5. The resonator-assembly procedure was modified to provide a high stress on the stack while the cement cured. This produced an improved Epon 8 cement joint with lower losses, eliminating the major cause of the current-runaway problem.
